Effects of thermal changes on Macael marble: Experimental study

J. Rodríguez-Gordillo ^{a,*}, M.P. Sáez-Pérez ^b

^a *Department of Mineralogy and Petrology, University of Granada, 18071 Granada, Spain*

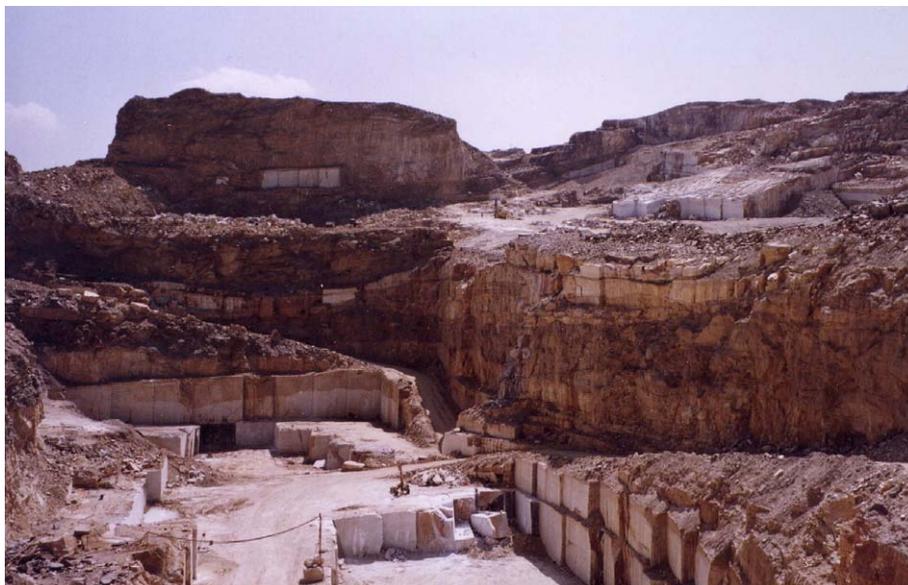
Fig. 1. View of “La Umbría” quarry from which the material tested in this paper was extracted.

The material for testing was taken from the La Umbría quarry approximately 1500 m from Macael at the place known as Umbría de las Canteras (Fig. 1). It is white marble with some greyish banding. At first $50 \times 50 \times 15$ cm blocks were cut, from which specimens measuring $5 \times 5 \times 15$ cm were later cut. These dimensions were chosen in order to fit the highest possible number of normalisations into the tests. The sample blocks were cut so that the direction of the greyish banding followed the largest dimension and lay parallel to one of the lateral faces. We decided to denominate the direction of the longitudinal axis H. The direction perpendicular to H and parallel to the greyish bands as F and the direction perpendicular to the bands as L.

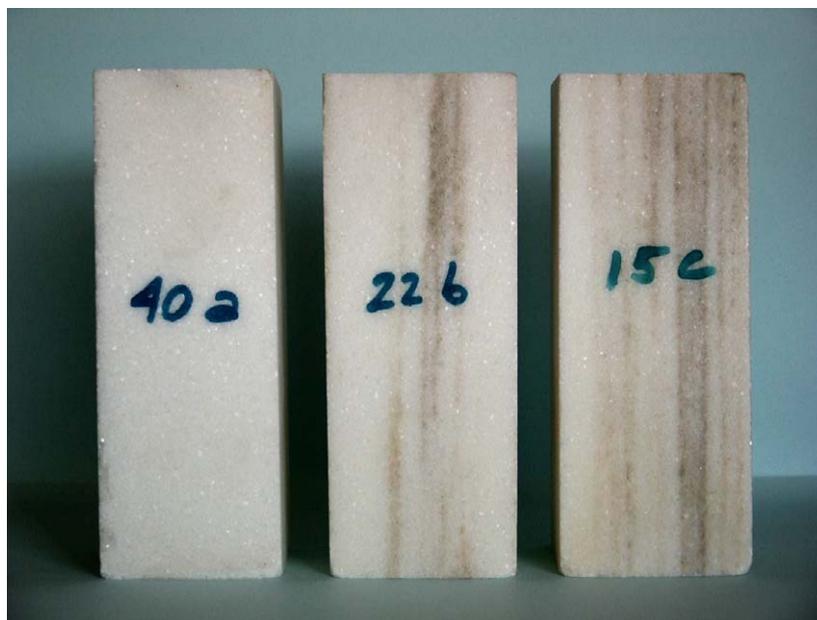
Fig. 2. Detail of the groups of sample blocks established: (a) (absence of banding), (b) (intermediate banding) and (c) (abundant banding).

The sample blocks were then classified into three groups according to the abundance of the banding. In group A the greyish banding is not present or can scarcely be detected, group B has medium abundance of banding and group C has the most banding (Fig. 2). The total number of blocks tested was 75 (25 per group).
