Neotectonics and slope stabilization at the Alhambra, Granada, Spain

Abstract

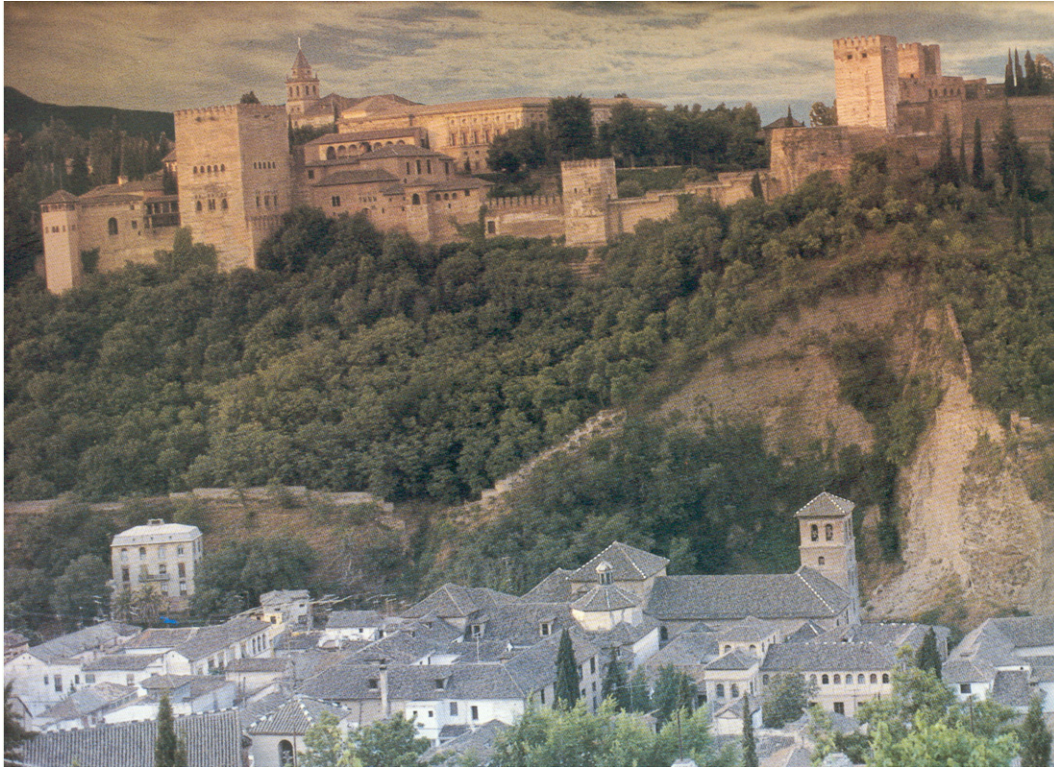
Fig. 1. South view of San Pedro Cliff, showing to the right the fault-line scarp. Above stand the Alhambra walls and, at the foot, River Darro and Albaicín houses.

side of the Alhambra hill has been a critical problem since the construction of this palace. In this area, the 65.5 m high San Pedro Cliff (Fig. 1), a dihedral 65.5 m high, is the steepest escarpment of the Alhambra hill. This eroding cliff reaches to 23.8 m from the Alhambra palace wall. Retreat of this cliff has occurred through superficial slab falls mainly induced by the floods of the Darro River, the loosening produced by the extensional tectonic regime, erosion, seepage coming from Alhambra palace and earthquakes. Fig. 2 shows, at the top, the southern part of the Iberian Peninsula and the Granada basin in an inset. This depression (Fig. 2, centre) is located in the central sector of the Betic Cordillera, and is one of the most seismically active zones in the Iberian Peninsula (e.g., Morales et al., 1999; Muñoz et al., 2002; Sanz de Galdeano et al., 2003; Galindo-Zaldívar et al., 2003). In this respect, the most important

earthquake affecting the Alhambra and neighbouring areas occurred in 1431, and was responsible for the partial collapse of the Arab barrier (Azañón et al., 2004). The Christian wall, built in 1526, has also been partially destroyed (Figs. 1 and 11) by rockfalls related to tectonic activity.

the upper half of the Christian wall has collapsed (Fig. 1). The eastern boundary of the collapsed barrier coincides with a normal fault that sinks the western block (Fig. 10). This fault produced a rupture in the barrier. Later escarpment retreat produced the collapse of the Christian wall on its right-hand side.

documented slab failure of 1985 (see Fig. 1) indicates that slides usually occur on one of the dihedral sides and are not three-dimensional. Although there is clast orientation in the direction of the fault (Fig. 9), the granular nature of the conglomerate guarantees that there is no strong strength decrease in this direction, as would happen in clay, shale or slate.

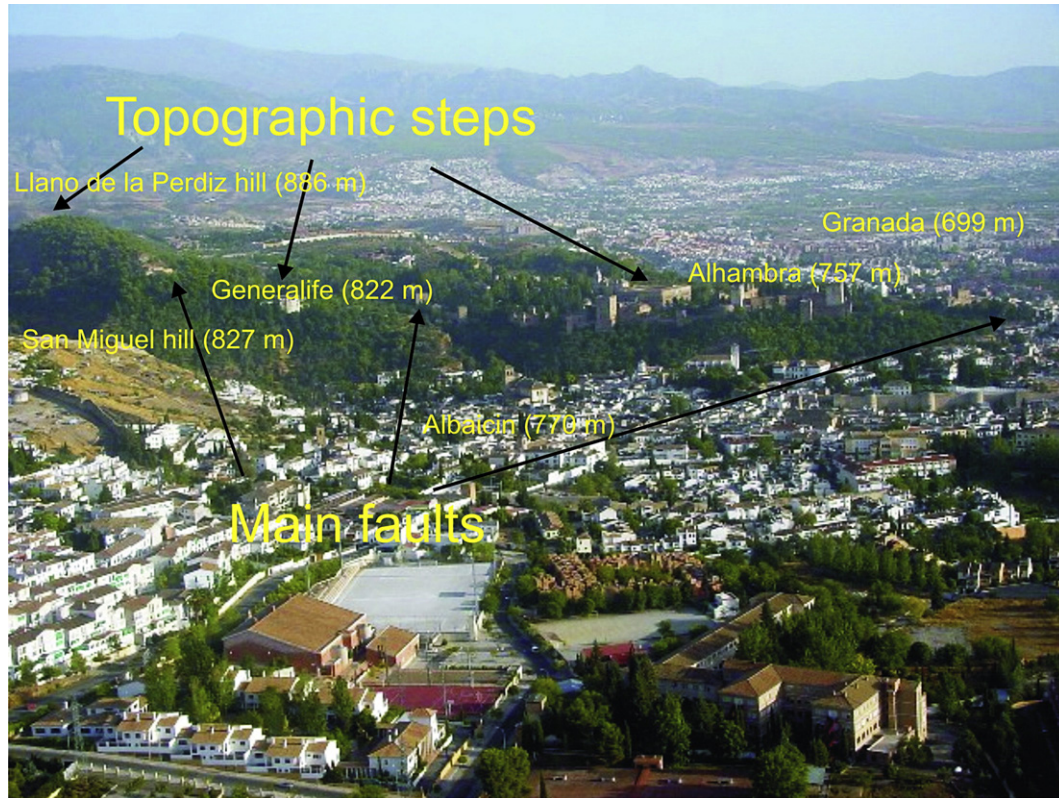
Fig. 3. Relationship between the following steps in the relief and faults: Llano de la Perdiz–Generalife, San Miguel hill–Albalcín, Generalife–Alhambra and Alhambra–Granada.

eastern part of the basin (Fig. 3), some of which limit the Granada basin, which have influenced the basin's stratigraphic architecture. The location of Fig. 3 is shown in Fig. 2. These faults are normal, mostly with a NW–SE orientation, and dipping towards the SW. These NW–SE faults cross-cut and displace previous E–W faults, defining the main subsiding areas of the central and eastern part of the basin. The Bouguer gravity map of the Granada basin shows that within the basin there are several more sectors that are subsident, where significant negative gravity values occur (Rodríguez-Fernández and Sanz de Galdeano, 2006).

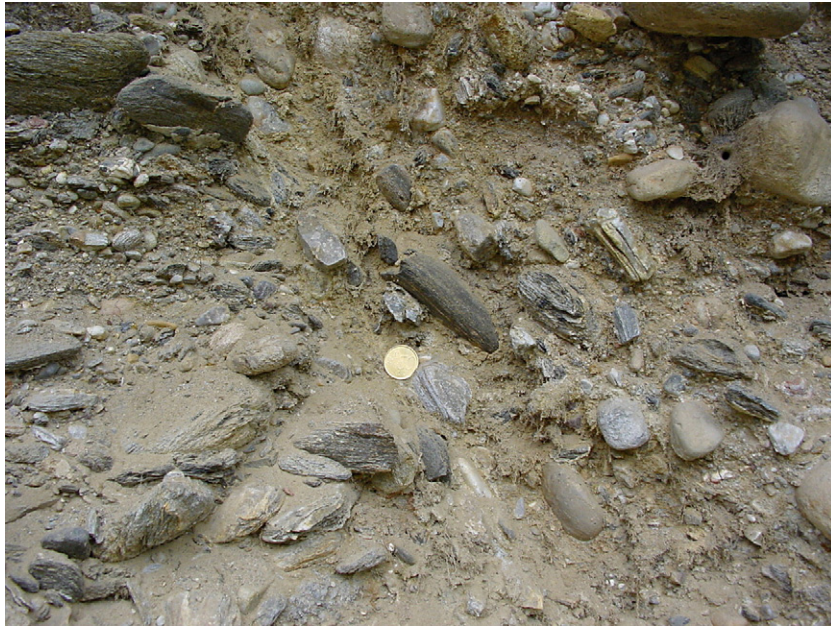
Fig. 9. Rotated pebbles, orientated parallel to the fault plane by shear strain in Alhambra conglomerate.

fault (Fig. 9). The matrix of the conglomerate is also disturbed with many shear surfaces parallel to the fault walls. Slickensides are common, always indicating shear displacement in the direction of the dip slip. Fractured clasts are found within and near the faults. The joints are parallel to the faults' strike and are compatible with tension gashes produced in the same stress field that generated the faults.

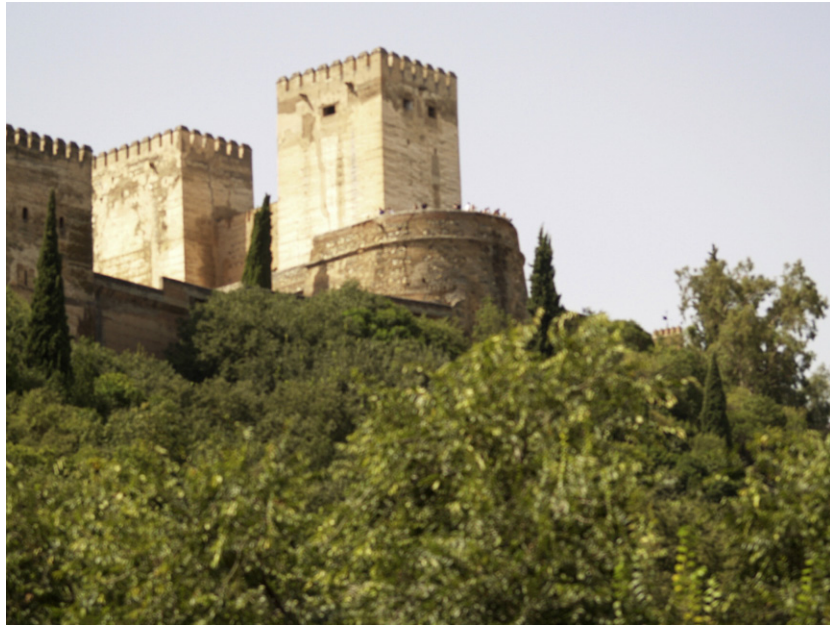
Fig. 12. Crack in Torre de la Vela.

The movement and tilt of the towers on the northern hill slope were controlled from January 1989 until October 1994. In the tower closer to the cliff (Torre de la Vela) there was cyclic vertical motion, with resultant settlement of less than 1 mm (v. Martínez, 1998). Fig. 12 shows a crack in *Torre de la Vela*, perhaps produced by motion towards the cliff.

The crack in the tower of Fig. 12 shows how motion towards the cliff has been detected rather far away from the cliff.

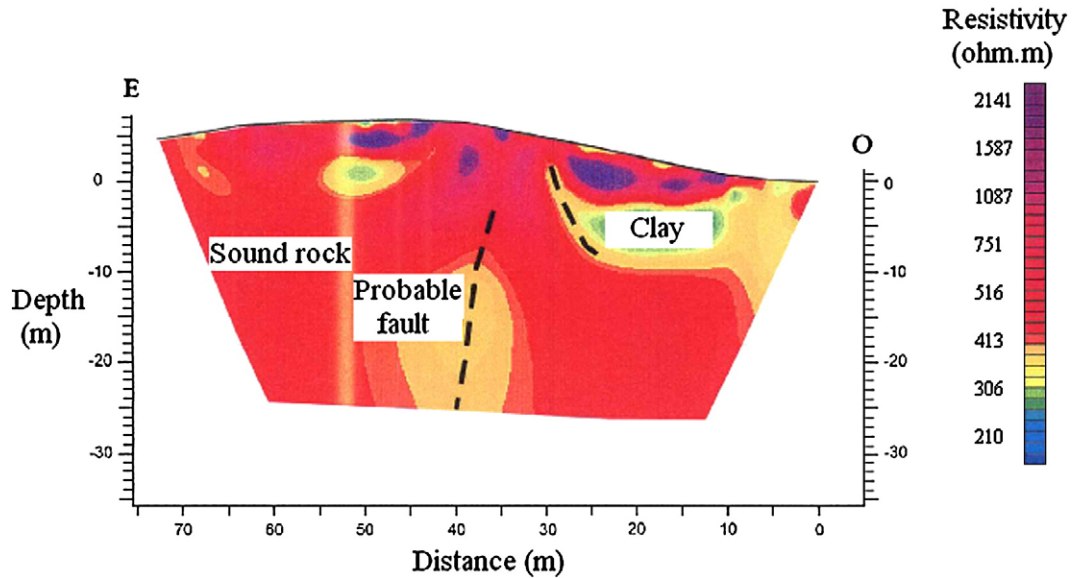
Fig. 15. Resistivity profile Te-1.

that appears in borehole S-2 (19 m apart), but not exactly at the same depth and with the same thickness. Furthermore, it must be noted that the site is in a shattered fault zone.

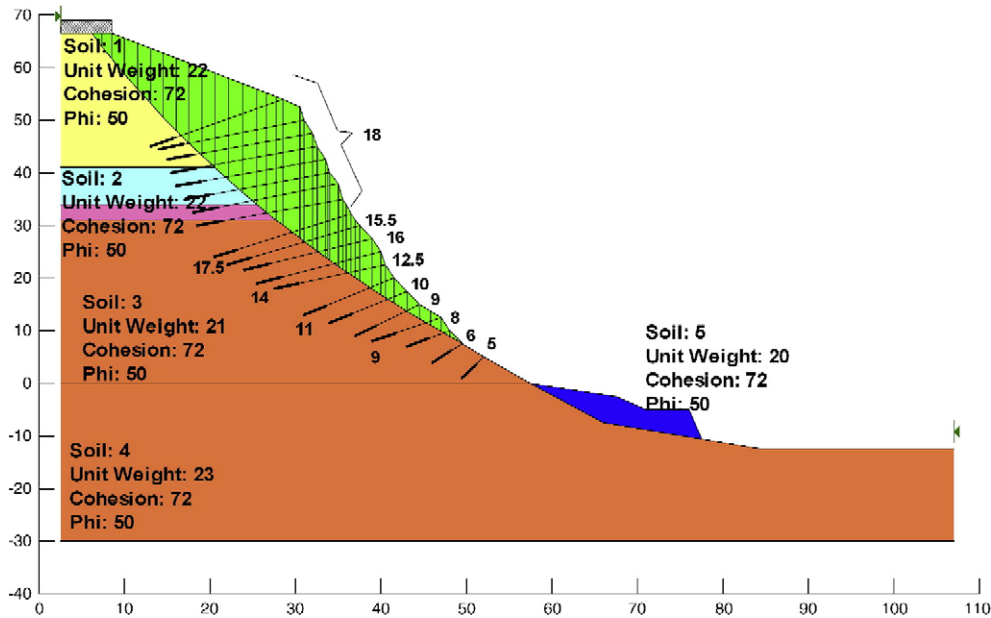
Fig. 17. Critical slip surface under dynamic conditions using Morgenstern and Price method and parameters' hypothesis 2. Anchor depth is indicated above each anchor.

Calculations of the static and pseudo-dynamic stability of the slopes have been carried out with the parameters corresponding to hypotheses 1 and 2 in Table 3. The Geo-Slope program and the Morgenstern and Price method were used in the calculations, with different mesh pressures applied on the slope. For the pseudo-dynamic calculations, the ground acceleration applied corresponds to the 1000-year return period (0.28 g), following the recommendations of the Spanish standard for monuments (NCS-94, 1994). This standard takes into account the geographical position of the site, the return period and the shear wave velocity of the ground. Only an equivalent horizontal calculation of seismic acceleration is provided by the standard. The results are included in Table 4. In most cases, the critical slip surface penetrates inside the Alhambra walls. For no pressure on the slope, the factor of safety under dynamic conditions is less than unity with both hypotheses. Fig. 17 shows the critical slip surface under dynamic conditions, for the design pressure of 20 kPa on the slope that was finally adopted.

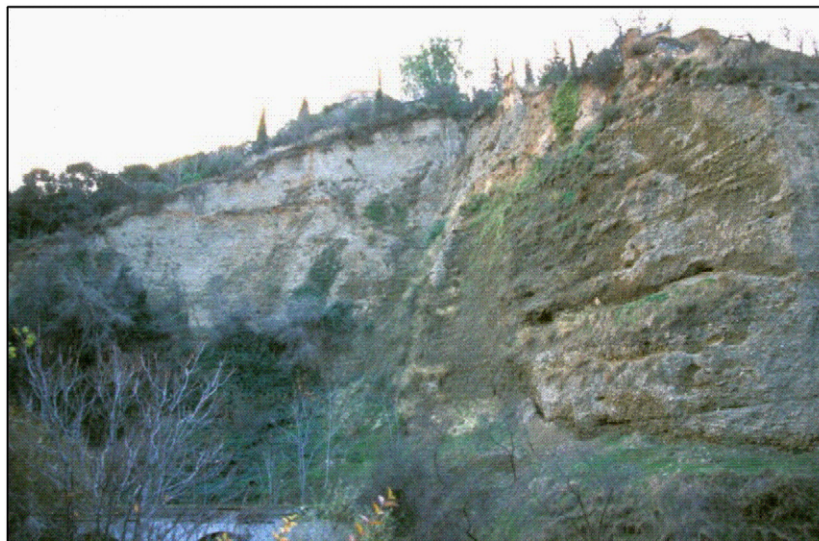
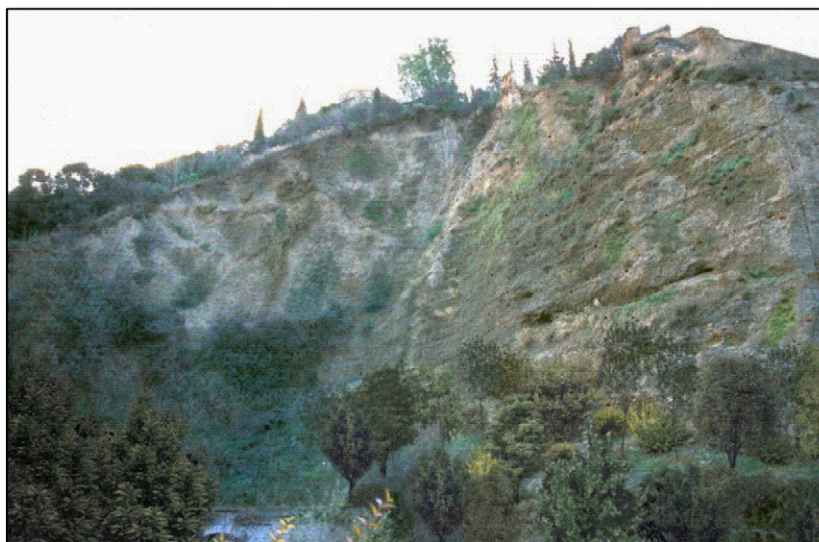
Fig. 20. San Pedro Cliff from an immediate vision field. A. Present state. B. Computer simulation showing the Cliff after reinforcement and plant growth.
